BULGARIAN FIGHTER COLOURS 1919–1948

Vol. 1

Rainbow No 9136

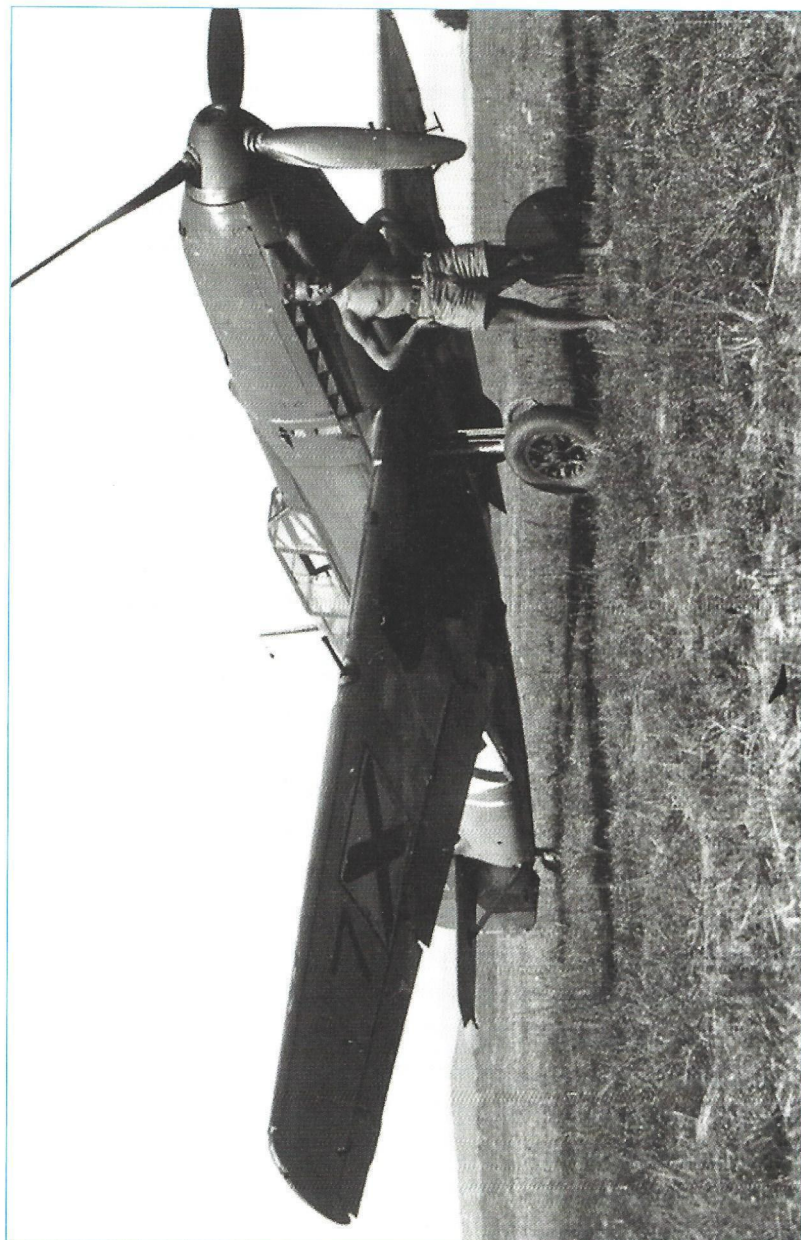
This photo of 'White 7' is a good example of how the early roundel-type military marking was covered with the new, square-like marking introduced in late June 1940. Circle slices still protrude from underneath the square, faintly visible on both the fuselage (see blow-up on page 283, top) and wing under surface. The retrofitted 2 cm Ikaria wing cannon, with circular patchwork around it on the wing leading edge, is noteworthy. The depicted muscular airman is 'Pavlo', i.e. Poruchik Pavel Evstatiev Pavlov. On the back of the photo he wrote the following: "To 'Tedi' (nick name of Todor Vălkov), as remembrance from Pavlov. Karlovo airfield, 29 June 1943."

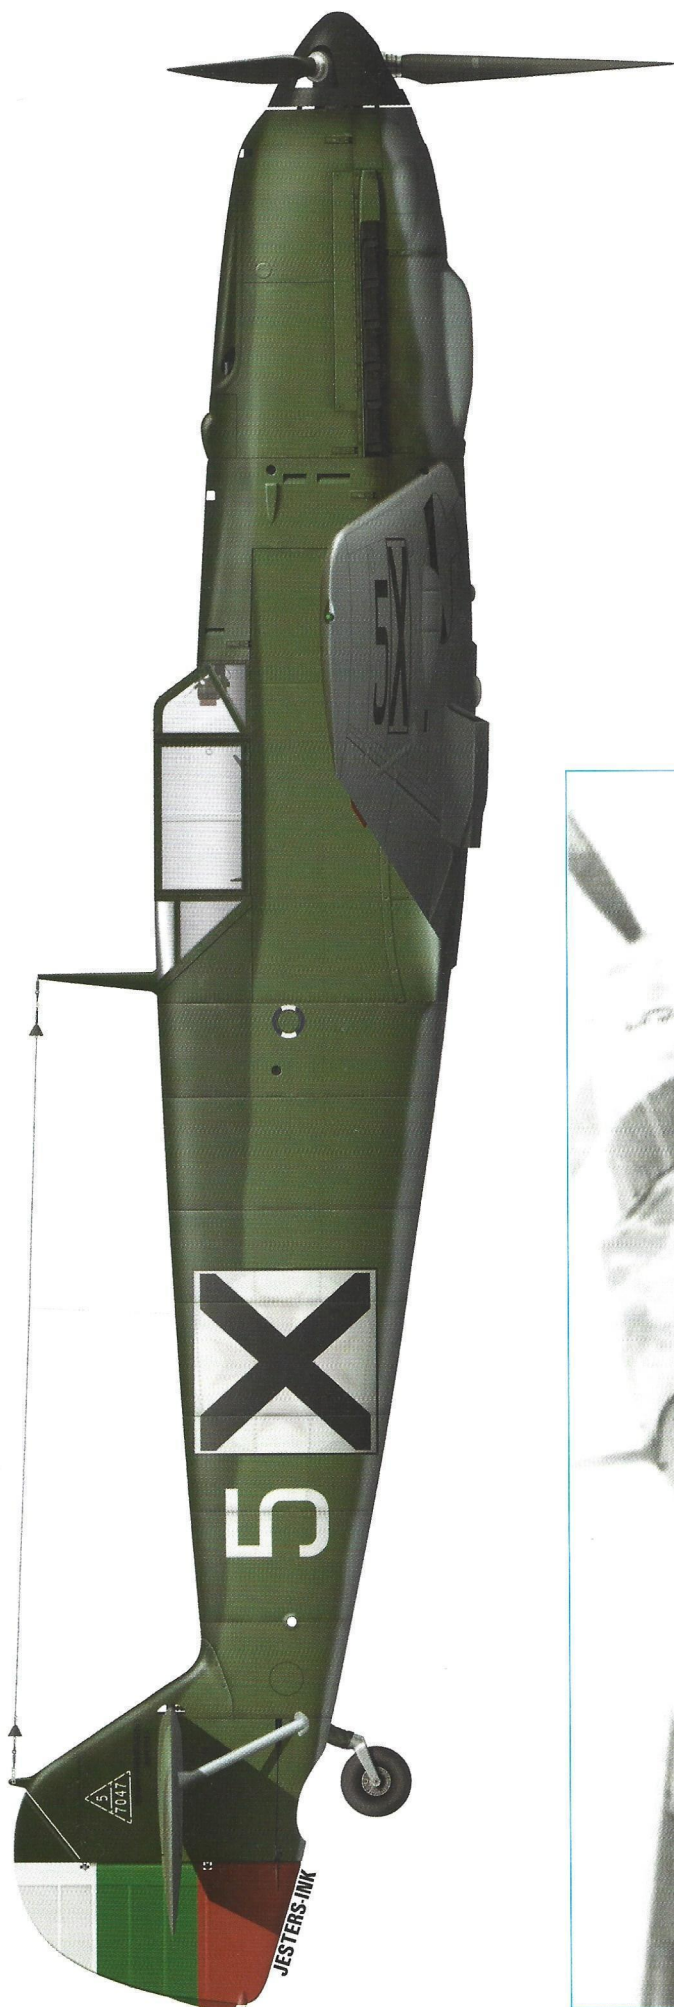
Messerschmitt Bf 109E-3 Strela (W.Nr. 5225), No. 5/7047, 6th Iztrebitelet Polk, 1/6. Iztrebitelet Orlyak, Marno-Pole airfield, July 1940. Camouflage colours: Dark Green (L 40/70 DKH) engine cowling upper area, fuselage spine and fin, mid-Green (L 40/62 DKH) fuselage sides. Wing upper surfaces the same Dark Green and mid-Green, applied in so-called 'splinter' scheme. All under surfaces Light Blue (L 40/65 DKH). White-Green-Red rudder. Propeller spinner Black Green (RLM 70), propeller blades Dark Green (RLM 71). Serial number in White on fuselage sides and in Black on wing under surfaces.

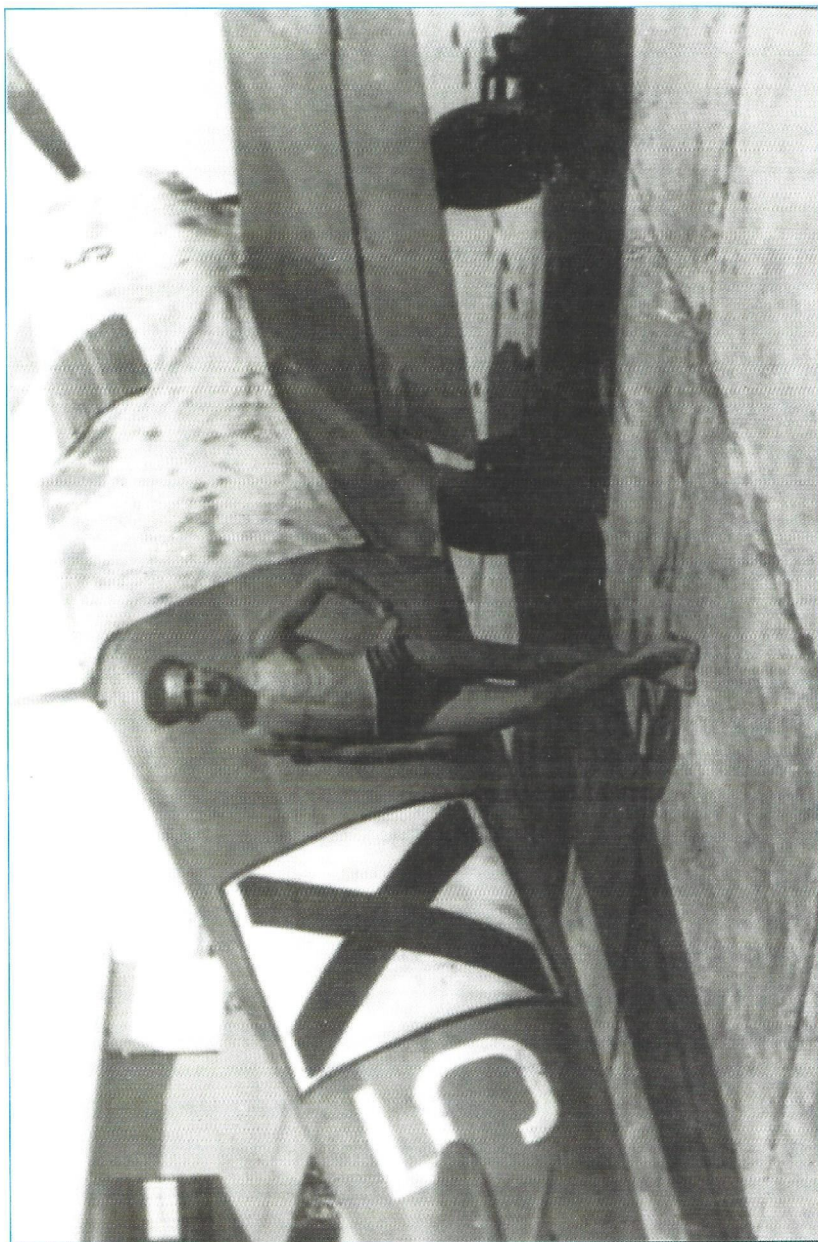
'White 5' received its new style 'pro-Axis' markings very recently, most probably in late June 1940. The previous, roundel-type markings can faintly be seen underneath the black bordered white square. This time, the square was large enough to entirely cover the roundel. The typical Bulgarian yellow 'arrow' flash, wrapping the engine cowlings and running along the fuselage sides, is yet missing. Notice the two-tone Green camouflage colours on the wings, applied in 'splinter' scheme. No. 5 suffered an accident sometime in the early summer of 1943, and was subsequently sent for repair to ASAM-Pipera workshop, located near Bucharest, Rumania, where all '109s in service with the Luftwaffe and its local allies, in need of major repair, were taken care of.

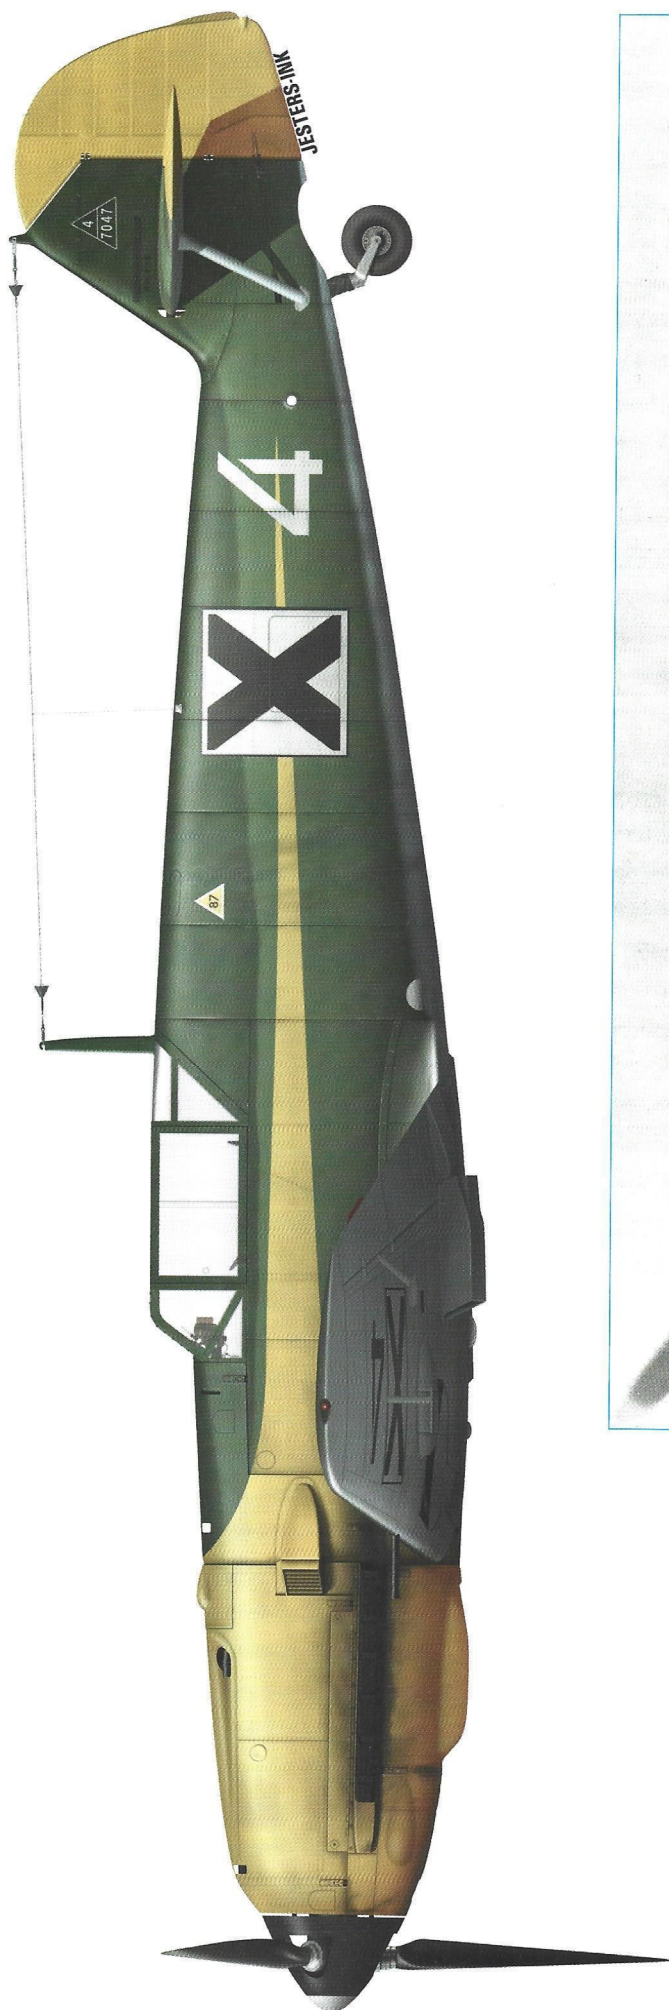
Messerschmitt Bf 109E-3 Strela (W.Nr. 5224), No. 4/7047, 1/6. Iztrebitelen Orlyak, pilot Poruchik Stoyan I. Stoyanov, Karlovo airfield, April 1941. Camouflage colours: Dark Green (L 40/70 DKH) engine cowlings upper area, fuselage spine and fin, mid-green (L 40/62 DKH) fuselage sides. Wing upper surfaces the same Dark Green and mid-green, applied in so-called 'splinter' scheme. All under surfaces Light Blue (L 40/65 DKH). Yellow (RLM 04) wraparound engine cowlings and rearward tapering flash along the fuselage sides, as well as rudder and elevators. Propeller spinner Black Green (RLM 70) with Light Grey tip, propeller blades Dark Green (RLM 71). Serial number in White on fuselage sides and in Black on wing under surfaces.

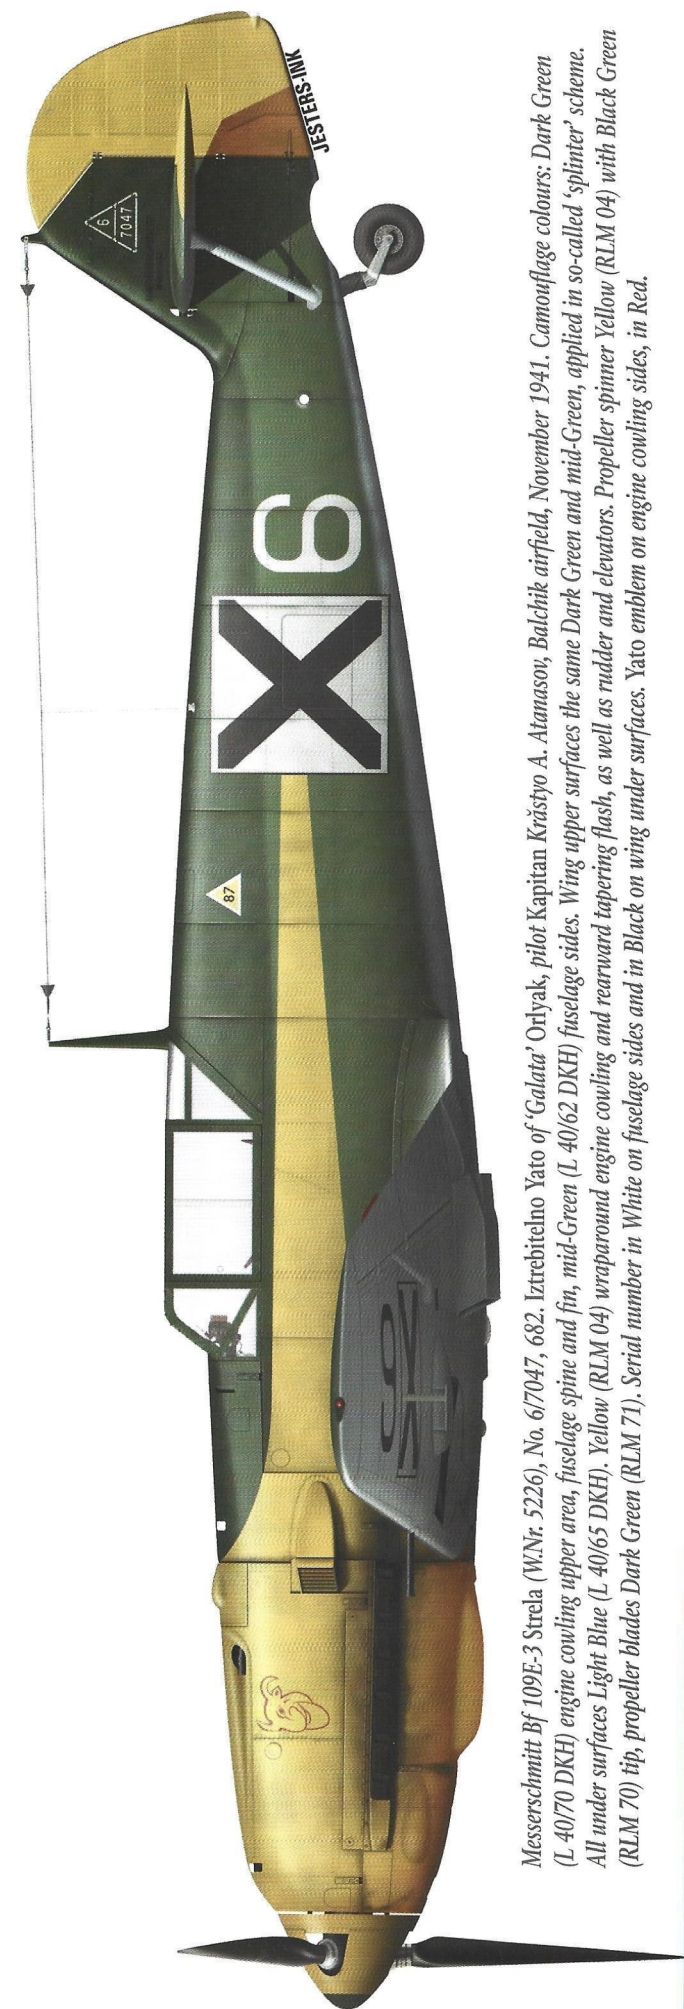
Messerschmitt Bf 109E-3 Strela (W.Nr. 5226), No. 6/7047, 682. Iztrebitelno Yato of 'Galata' Orlyak, pilot Kapitän Krästy A. Atanasov, Balchik airfield, November 1941. Camouflage colours: Dark Green (L 40/70 DKH) engine cowlings upper area, fuselage spine and fin, mid-Green (L 40/62 DKH) fuselage sides. Wing upper surfaces the same Dark Green and mid-Green, applied in so-called 'splinter' scheme. All under surfaces Light Blue (L 40/65 DKH). Yellow (RLM 04) wraparound engine cowlings and rearward tapering flash, as well as rudder and elevators. Propeller spinner Yellow (RLM 04) with Black Green (RLM 70) tip, propeller blades Dark Green (RLM 71). Serial number in White on fuselage sides and in Black on wing under surfaces. Yato emblem on engine cowlings sides, in Red.

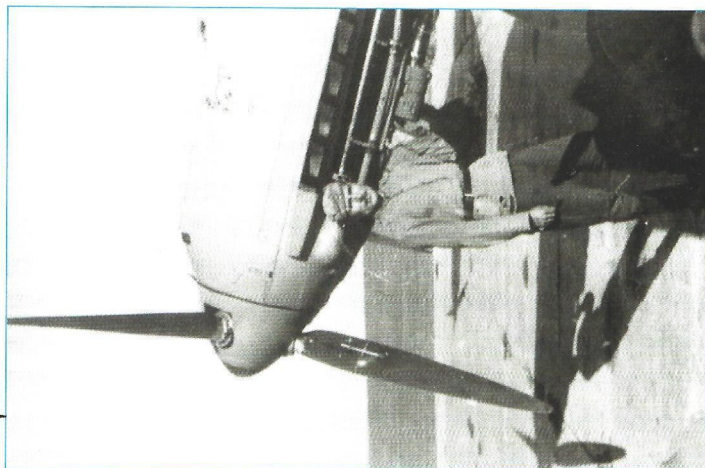
'White 6' was one of the aircraft assigned to the so-called 'Galata' Orlyak, defending the Black Sea coastline against Soviet intruders. While dispatched to the seaside airfield of Balchik, reportedly it wore an emblem, depicting a devilish figure outlined in red. The emblem was reportedly painted on Strelas based at Balchik (682. Yato). The accident shown in this photo happened on 2 August 1942, when the aircraft piloted by Kpt. Doncho N. Dimitrov veered to the left while landing on Marno-Pole airfield, and broke the port undercarriage.

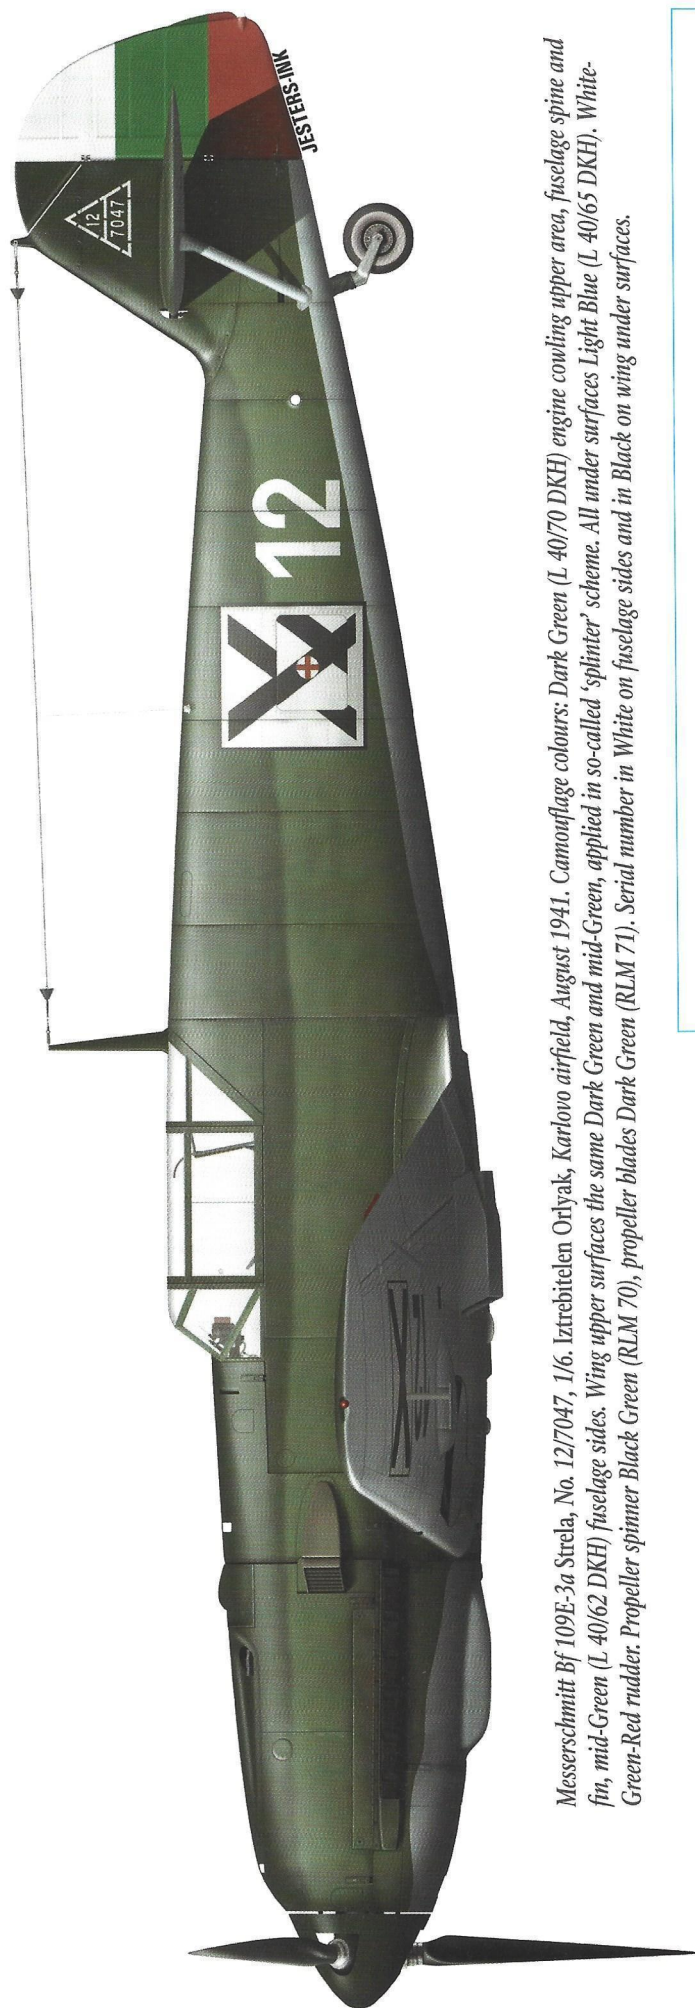
Messerschmitt Bf 109E-3a Strela, No. 12/7047, 1/6. Iztrebitelen Orlyak, Karlovo airfield, August 1941. Camouflage colours: Dark Green (L 40/70 DKH) engine cowling upper area, fuselage spine and fin, mid-Green (L 40/62 DKH) fuselage sides. Wing upper surfaces the same Dark Green and mid-Green, applied in so-called 'splinter' scheme. All under surfaces Light Blue (L 40/65 DKH). White-Green-Red rudder. Propeller spinner Black Green (RLM 70), propeller blades Dark Green (RLM 70), serial number in White on fuselage sides and in Black on wing under surfaces.

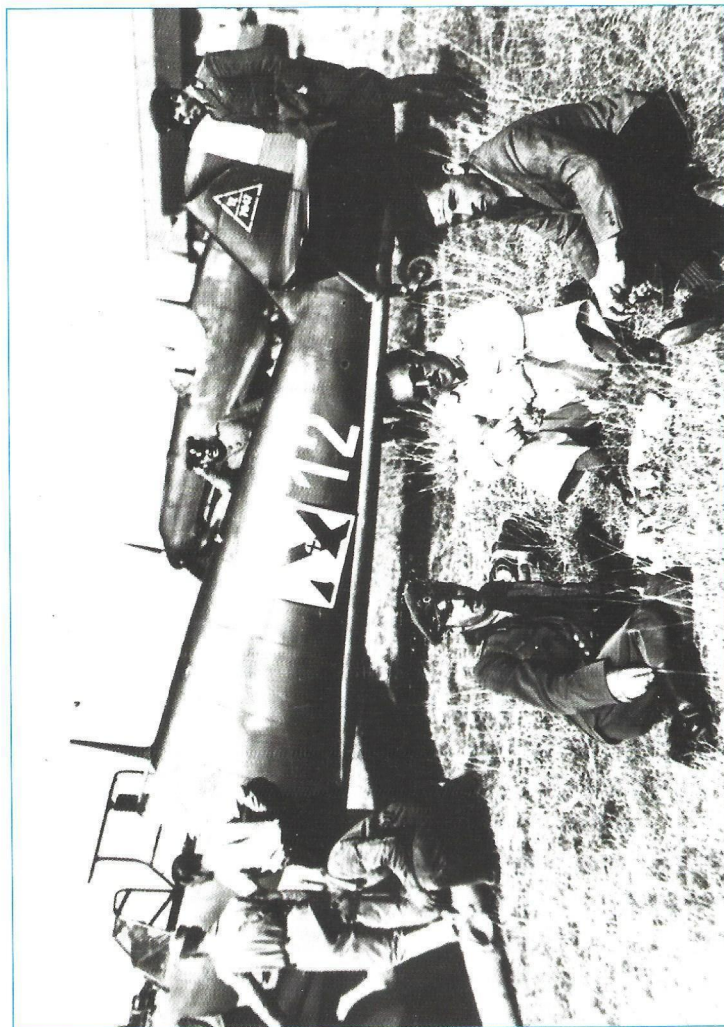
This snapshot taken at Karlovo airfield in August 1941 shows the assembly of the aircraft of the second batch that had been delivered by train. Notice how the port wing is about to be lifted in position, as the light grey painted area on the lower fuselage, where the wing will be fastened to, appears to be white. Interestingly, the cockpit canopy is of earlier, rounded design, peculiar to the Bf 109E-1s and E-3s. The people in the foreground are top Bulgarian pilot Stoyan Stoyanov (at left, in uniform), who would test fly the aircraft to be handed over by the Germans to the VNW, and two German airmen (centre and right), said to be flying instructors. The rudder was painted in Bulgarian colours at the workshop in Germany, and would very soon be overpainted with 'Axis yellow'. The wheel bay for the tail wheel was faired over with a thin plate, thus the lower tail contour appears to be straight. The camouflage scheme worn by this particular aircraft caused considerable headache to the Author. Although throughout the years he has instructed several artists on how to paint dozens and dozens of aircraft profiles based on black/white photographs, this time he could draw no firm conclusion. The camouflage scheme of aircraft No. 12 worn on the fuselage could have been either the original two-tone style (L 40/70 and L 40/62) used on the first batch of Emilis, with dark green wavy stripes applied on certain areas, or plain monotone Dark Green (possibly RLM 71), and only the sunlight reflecting off the uneven surface of the stressed metal skin playing tricks on the onlooker. The first version is strengthened by the fact that the dividing line between two camouflage colours can be clearly seen on the upper area of the engine cowling on the aircraft in the background. In the end, after much debate, the balance tipped in favour of the standard Bulgarian two-tone green upper camouflage scheme.

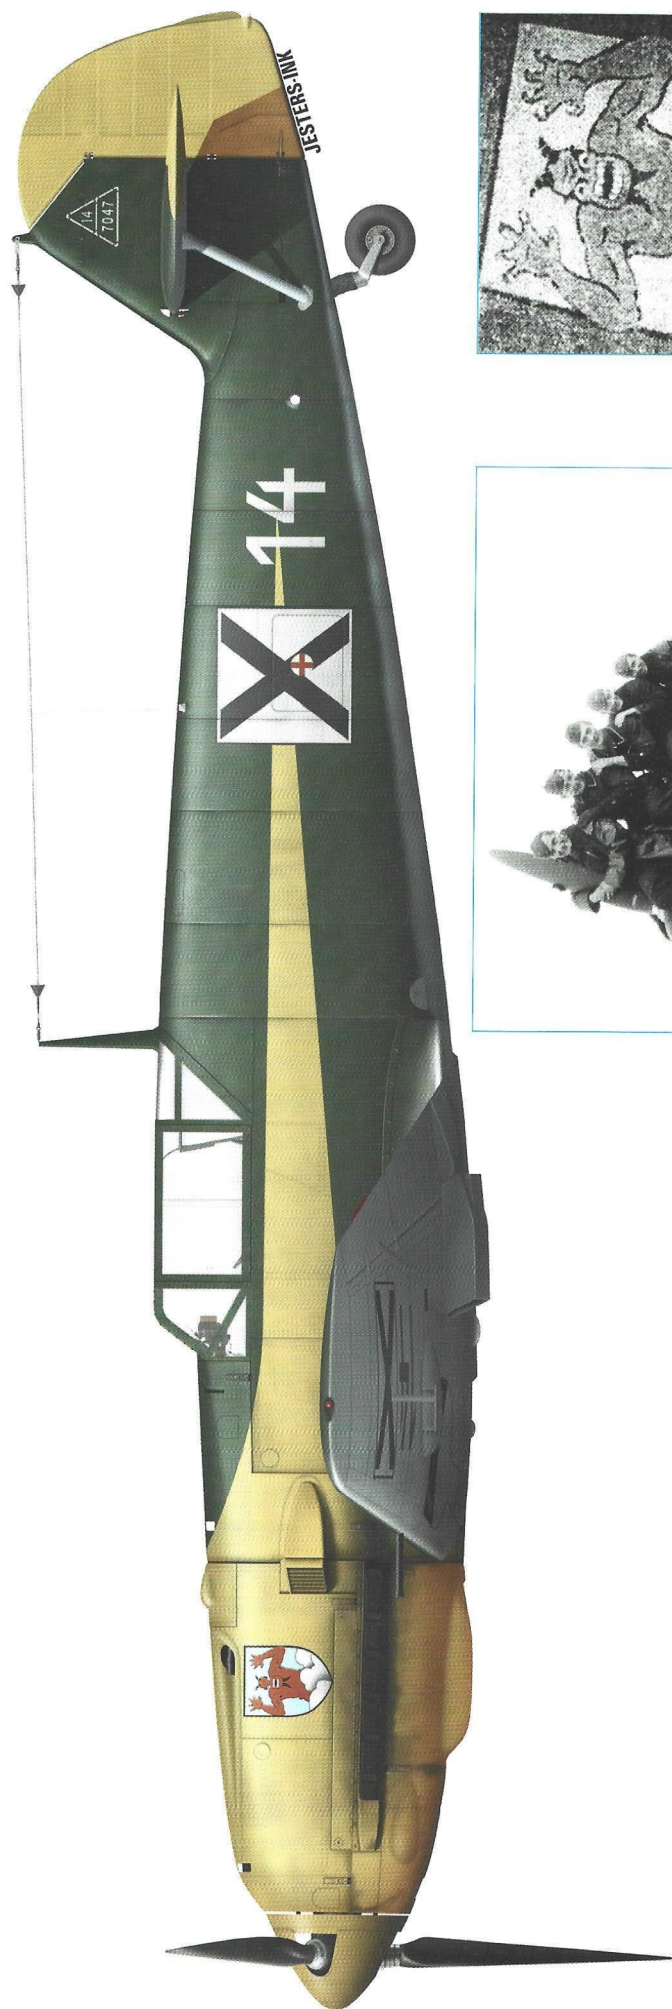
Messerschmitt Bf 109E-3a Strela, No. 14/7047, 692. Iztrebitelno Yato of 'Galata' Orlyak, pilot Podporuchik Mihail G. Grigorov, Sarafovo airfield, November 1941. Camouflage colours: Dark Green (L 40/70 DKH) fuselage and fin, as well as wing upper surfaces. All under surfaces Light Blue (L 40/65 DKH). Yellow (RLM 04) wraparound engine cowlings and rearward tapering flash along the fuselage sides, as well as spinner, rudder and elevators. Propeller blades Dark Green (RLM 71). Serial number in White on fuselage sides and upper wing surfaces, while in Black on wing under surfaces. Yato emblem on engine cowlings sides.

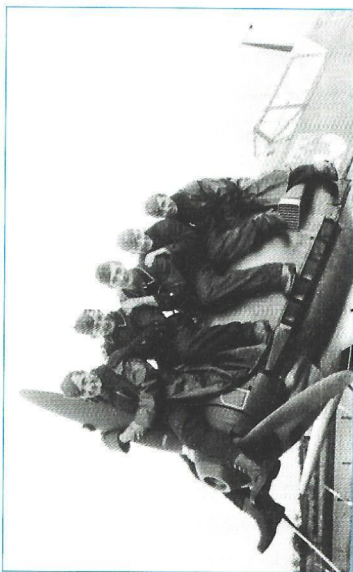
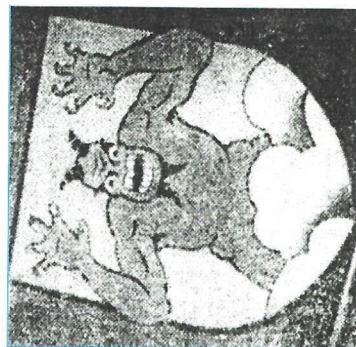
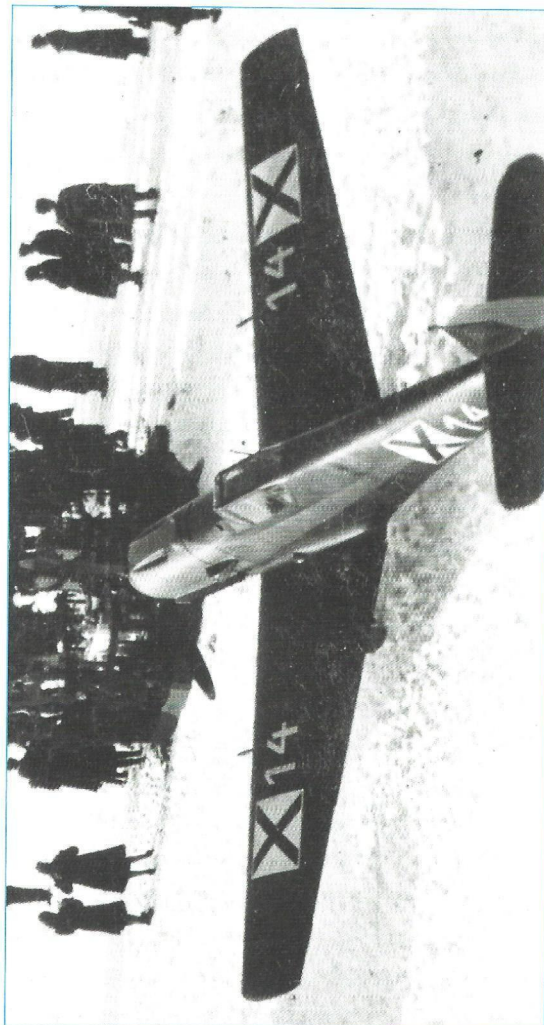
No. 14 was the personal mount of Podporuchik Mihail Grigorov, identified in the archives as such (and not No. 11, as often depicted). Aboard it, Grigorov jumped on a formation of P-38 Lightnings that dive bombed Skopje railway station on 21 October 1943, claiming one of them. Strela No. 14 is depicted on Karlovo airfield, during a ceremony held on 30 January 1943. Notice the aircraft's serial number painted in white on the all-green upper wing – typical feature of the Emilis of the second batch painted in monotone green. The 'Red Devil' walking on clouds, looking for its prey' emblem (clearly inspired by the Staffel emblem of the Luftwaffe's 2./JGr. 101, or later by the Gruppe emblem of IV./JG 1, only the colours being slightly different) is equally reported as Grigorov's personal sign, or as used on Srelas dispatched to Sarafovo (692. Yato), as part of the coastal defence 'Galata' Orlyak (the most likely version). The Luftwaffe Bf 109E depicted at top left was part of 2./JGr. 101 in late 1939, as identified by the Staffel emblem. The background of the shield here was yellow, opposite to the more realistic light blue, as used in the Bulgarian version (see detail photo from Bulgarian sources at top, right).

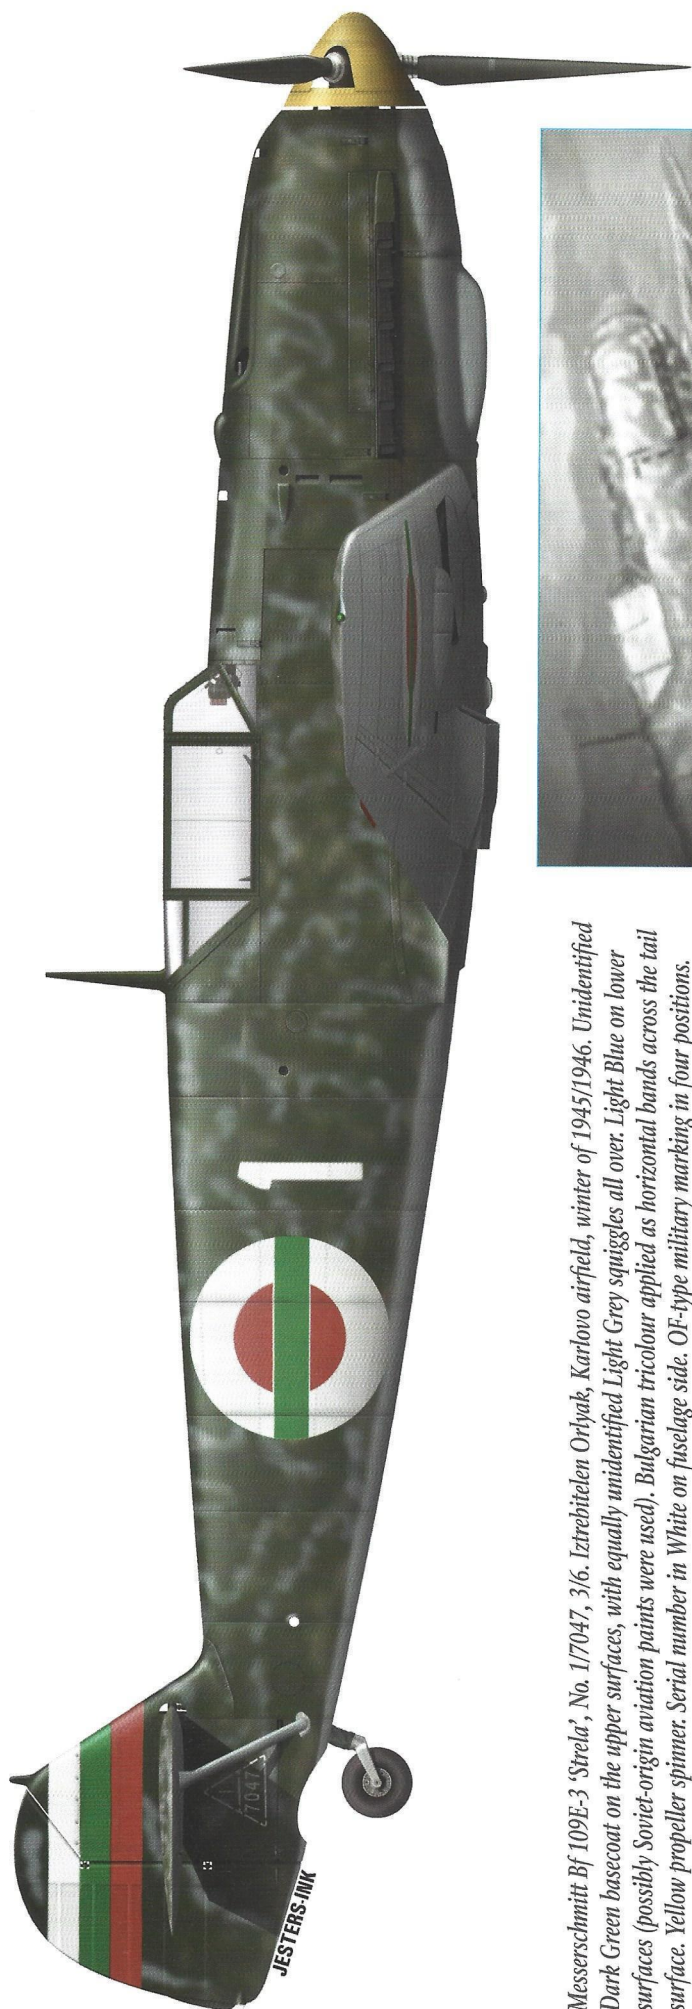
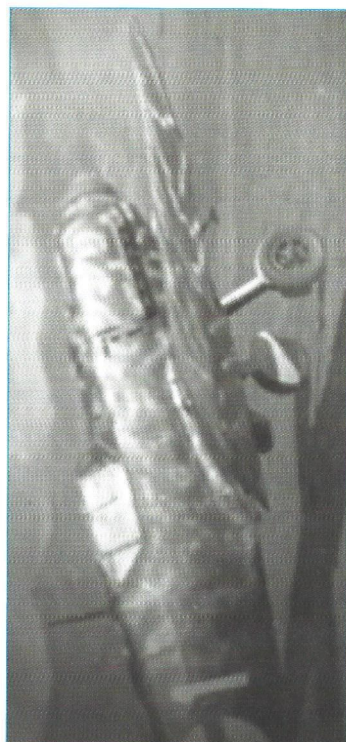
Messerschmitt Bf 109E-3 'Strela', No. 17047, 3/6. Iztrebitelen Orlyak, Karlovo airfield, winter of 1945/1946. Unidentified Dark Green basecoat on the upper surfaces, with equally unidentified Light Grey squiggles all over. Light Blue on lower surfaces (possibly Soviet-origin aviation paints were used). Bulgarian tricolour applied as horizontal bands across the tail surface. Yellow propeller spinner. Serial number in White on fuselage side. OF-type military marking in four positions.

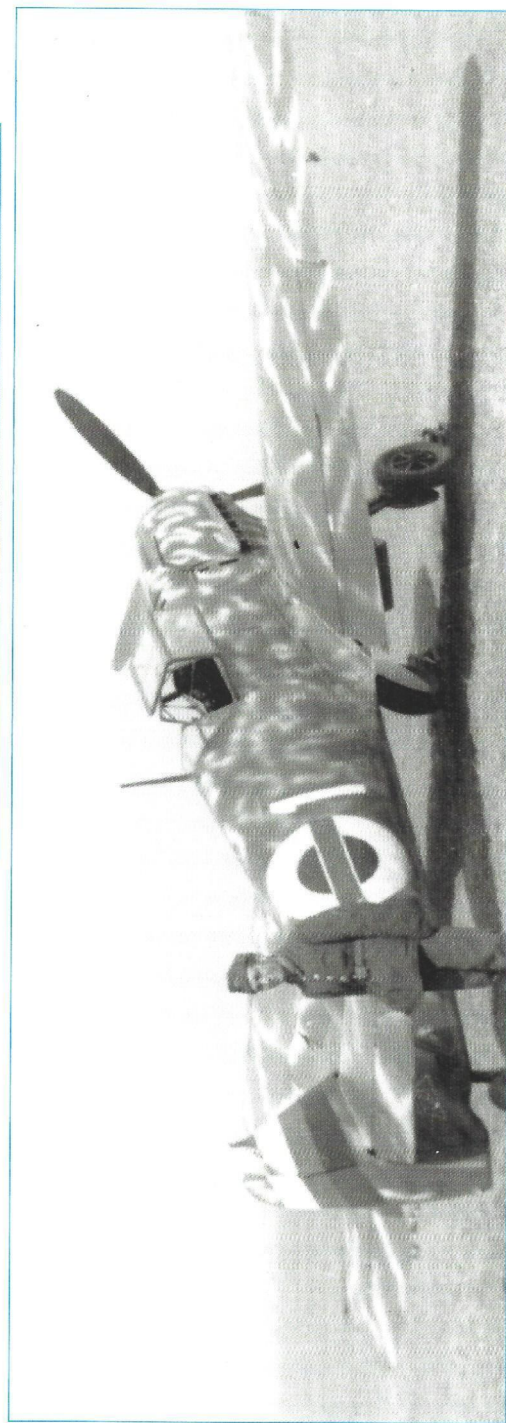
This is one of the only two known photos (plus one still from a period movie, at top right) that show a Bf 109E with the so-called 'Fatherland's Front' (OF) markings, introduced immediately post war. The colours worn by the aircraft are unidentified, and left to the reader to ascertain. The Author believes the camouflage scheme was very similar to the so-called 'assault camouflage', worn by Avia B.534s and D.520s, consisting of Dark Green over Light Blue, with Light Grey squiggles all over the upper surfaces. The origin of the paints is also unclear, could be of Soviet manufacture. This original photo (which was made on 'raster' type photopaper) has been signed on the back by the top-scoring Bulgarian pilot, Cpt. Stoyan Stoyanov, and was addressed to Col. Donevski.
